REPORT OF TELEVISION BOREHOLE SURVEY
OF A WELL
AT THE PATTERSONVILLE SERVICE AREA
ON THE NEW YORK STATE THRUWAY

BOREHOLE TELEVISION SURVEY

Pattersonville Service Area - N.Y.S.T.A.

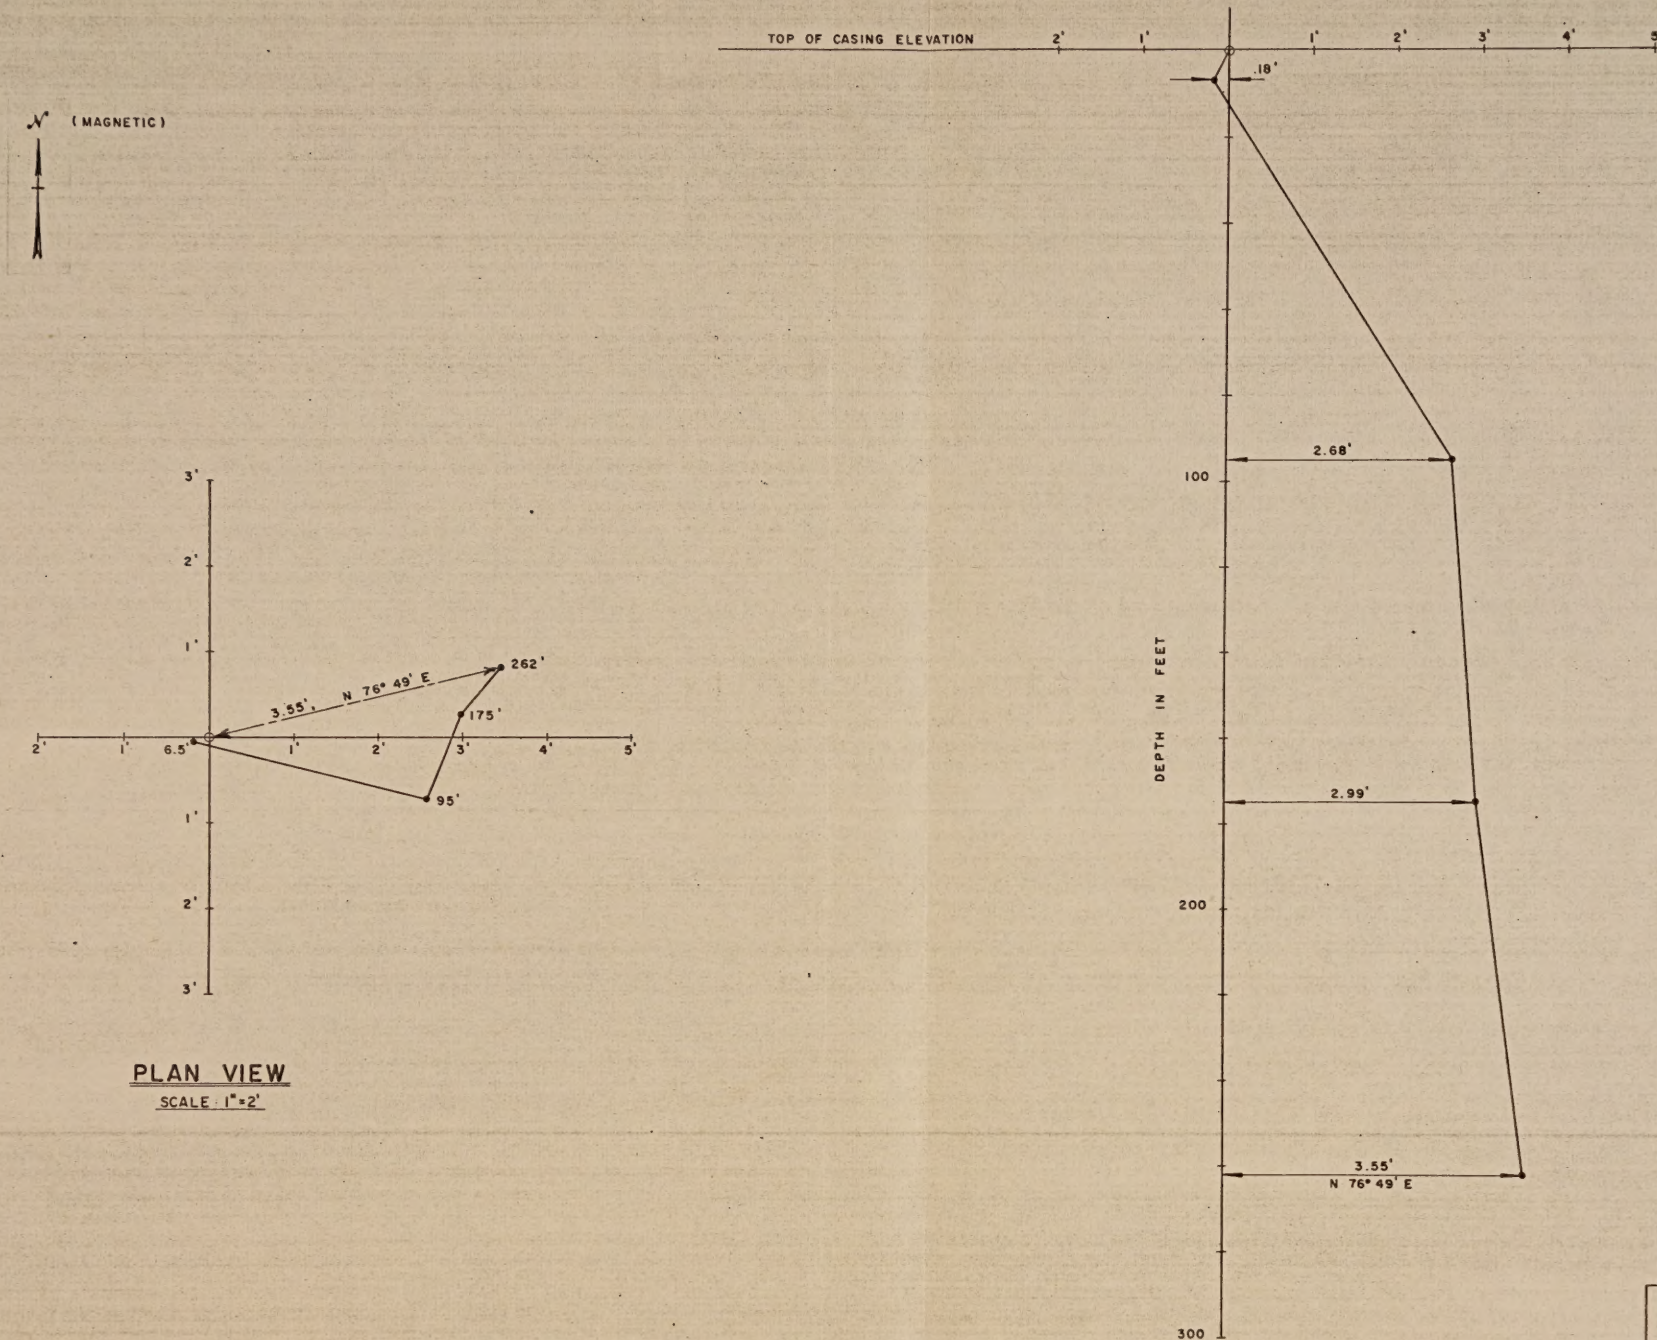
Fig. 2

The reason for the hangup is evident in the accompanying drawing (Fig. 2). According to Mr. Paul H. Bird of this Bureau, "This well went off plumb soon after it was started." Attempts made to straighten it with wedges on the way down resulted in the corkscrew pattern shown in Fig. 2. The reverse bend at six feet was probably made in an attempt to straighten the casing after it was seated. There are twelve threads of the coupling visible at this joint. The joint is about one foot below the bottom of the 12-inch casing and two and a half feet below the top of rock. The seal on the six-inch pipe passed this bend but eventually hung up because of friction at three points: (1) between the seal and the side of the casing below the bend at six feet, (2) the sides of the six-inch pipe rubbing against the bend, and (3) against the top of the casing opposite the bend.

The casing appears intact except for the joint at six feet where approximately one inch of threads are exposed. Leakage here, near the top of rock, would agree with the report of increased silt after heavy rainfalls. Since the seal can be inserted

The casing appeared to be well seated. The rock below the casing was fractured for a few inches because of the impact of the casing. However, there did not appear to be anything abnormal here.

Short of drilling a new well, the recommended procedure from here is -

a) Set a seal below the joint at the six foot level
and run a pump test.

b) If the silt persists, then straighten the bend at
six feet and set the seal below the "decomposed
granite" at 320 feet more or less.
